## SURFACE-INITIATED ROLLING CONTACT FATIGUE ON A DENT: MICROSTRUCTURAL EVOLUTION AND EFFECTS ON THE FAILURE MECHANISM

A. Goigoux<sup>a\*</sup>, S. Cazottes<sup>c</sup>, N. Biboulet<sup>b</sup>, F. Ville<sup>b</sup>, T. Douillard<sup>c</sup>, M. Véron<sup>d</sup>, P.E. Dubois<sup>a</sup>, C. Sidoroff<sup>a</sup>

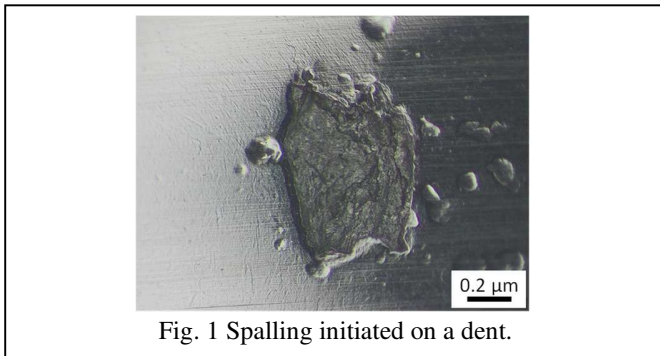
Fig. 1 Spalling initiated on a dent.

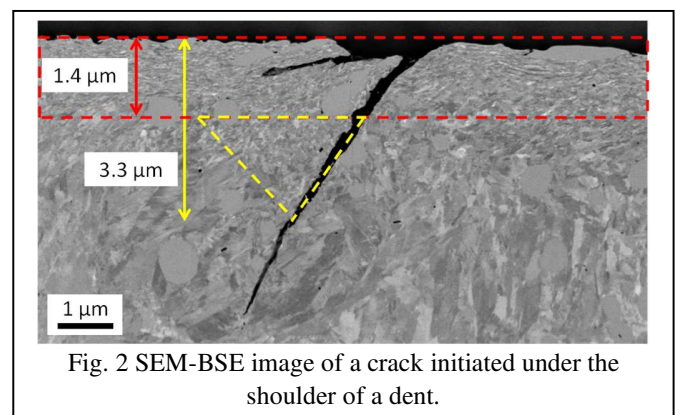
Fig. 2 SEM-BSE image of a crack initiated under the shoulder of a dent.

This study highlights the significance of shoulder plasticity in the initiation and propagation of cracks. Indeed, microstructural changes are confined under the dent of the shoulder. These alterations mainly consist in reorientation and fragmentation of the martensite into nanograins and spreading or shearing off the carbides. Based on these observations a plasticity mechanism is proposed for short crack initiation and propagation in case of surface RCF due to dent.
